# case study bulletin

### **Remediation Trial at The Avenue Using Thermal Treatment**

This bulletin describes a CL:AIRE Technology Demonstration Project (TDP10) in which contaminated material from The Avenue in Chesterfield, Derbyshire was treated using thermal treatment.

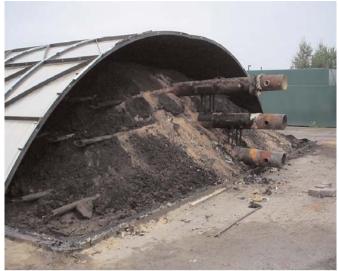
Figure 5: Completed Treatment Cell 2, from the thermal oxidiser end.

Cell 2 was constructed after Cell 1 had been treated and decommissioned. It was subdivided into three sections, each subdivision receiving different types of material. The section closest to the burners, approximately 6 m long, was built using spent oxide; the second section, again about 6 m long, was built using a mix of spent oxide and plant area material. The remaining and largest section, at approximately 12 m long, was constructed with waste tip material.

Pre-treatment samples were taken and the Quonset hut erected as described for Cell 1. The thermal oxidiser was used from the start on this cell, and commissioned over the first few days to achieve maximum performance. After treatment, when the performance samples were being taken, some additional samples were taken from materials suspected to be sulphur and naphthalene residues.
